**High Heat Flux Actively Cooled  
Honeycomb Sandwich Structural  
Panel for a Hypersonic Aircraft**

**L. C. Koch and L. L. Pagel**

**CONTRACT NAS1-12919  
DECEMBER 1978**

# NASA Contractor Report 2959

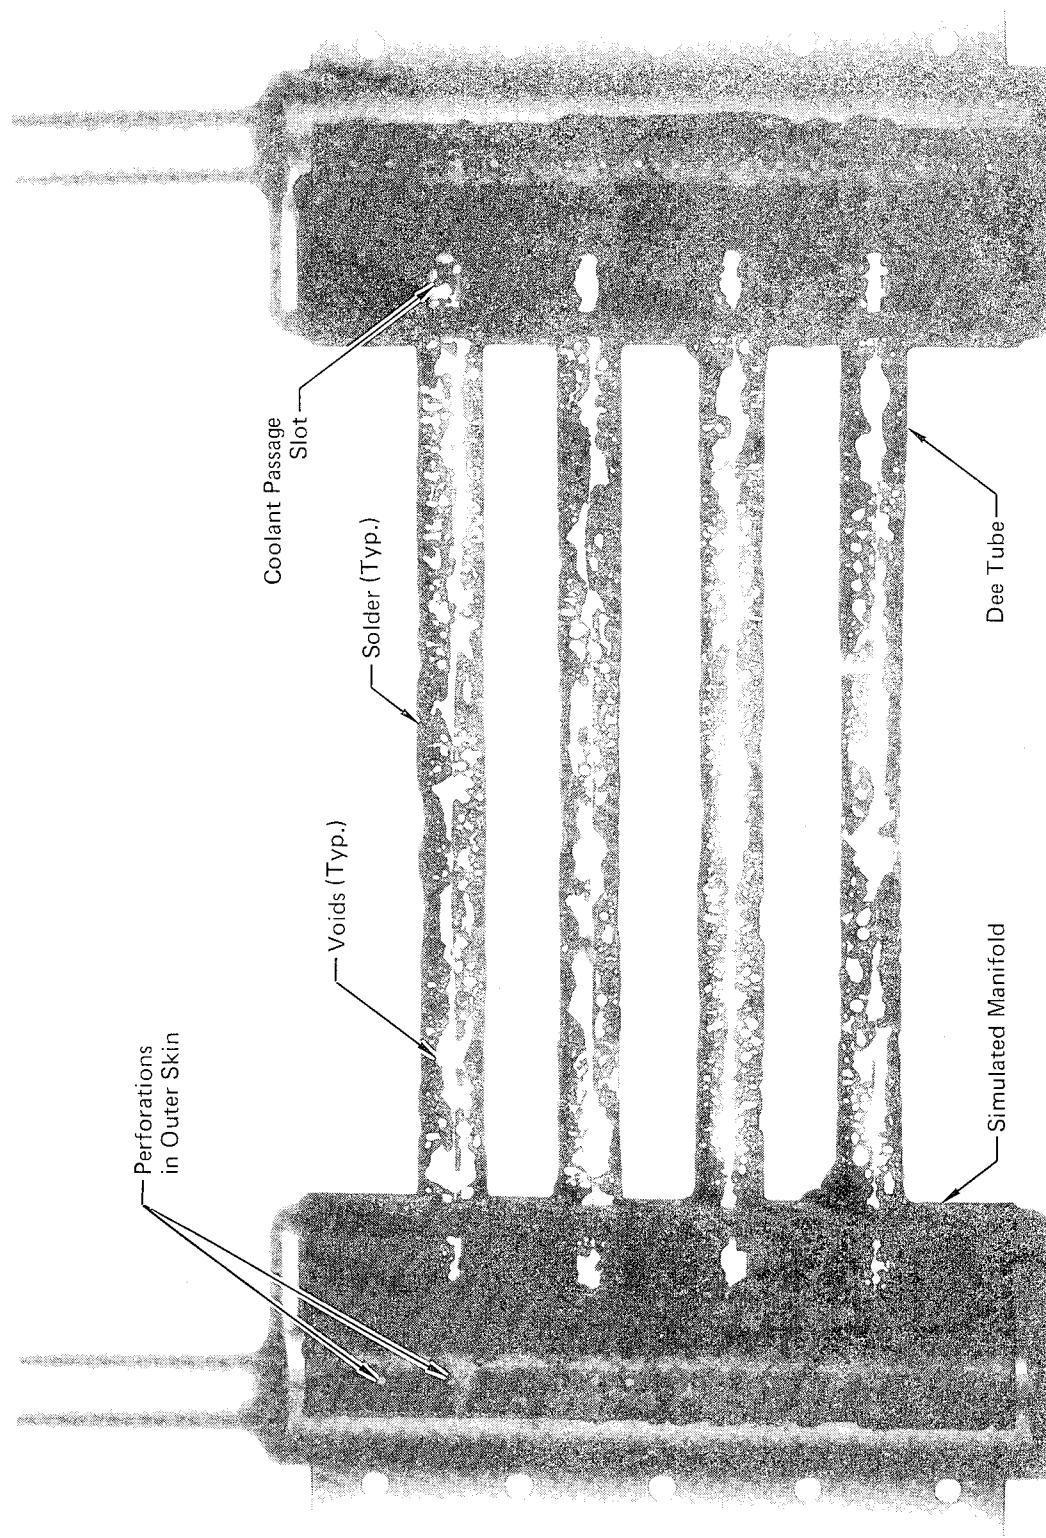
FIGURE 66  
RADIOGRAPH POSITIVE OF SOLDERED  
SKIN/DEE TUBE/MANIFOLD SPECIMEN

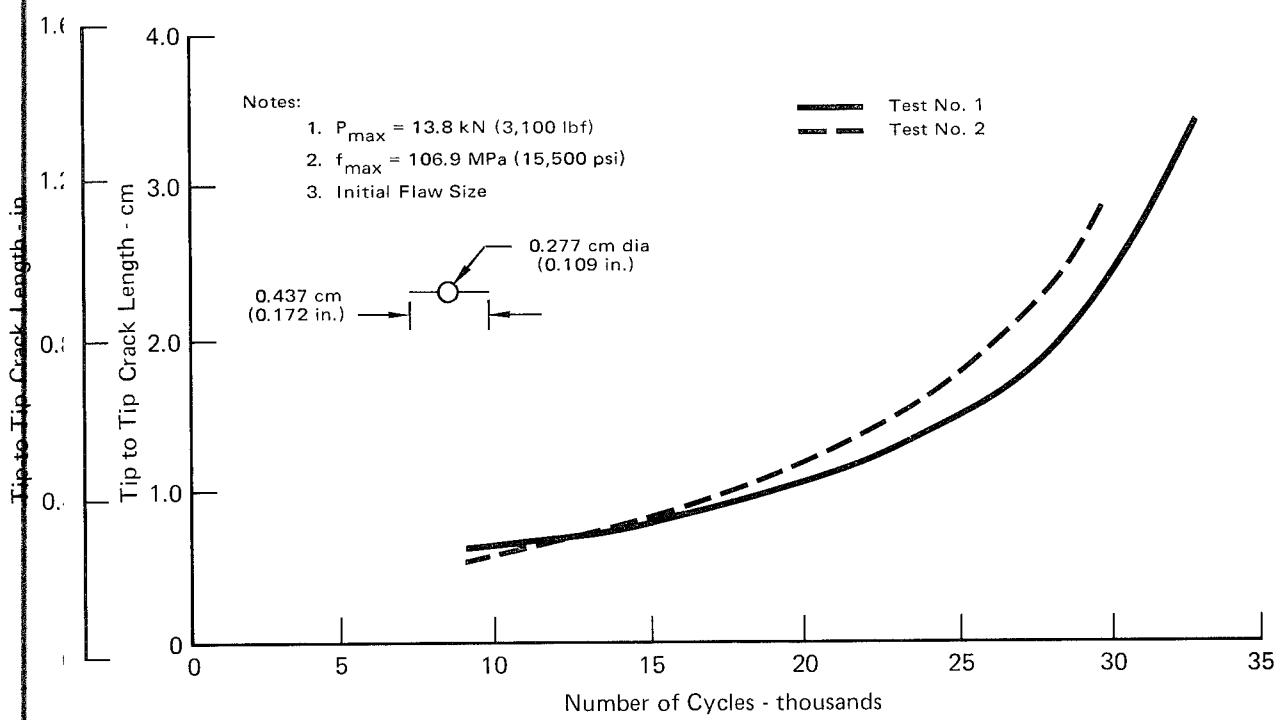
FIGURE 67  
BASIC SKIN SPECIMEN - FATIGUE CRACK PROPAGATION

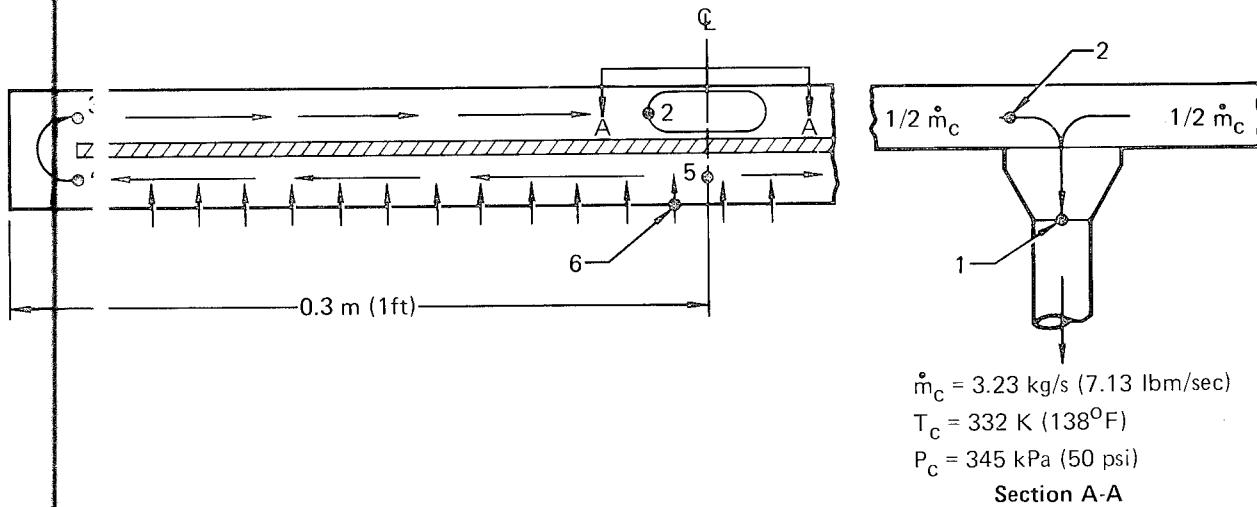
**FIGURE 76**  
**TEST PANEL INLET MANIFOLD PRESSURE DROP**

A detailed pressure drop analysis was performed for the inlet and exit manifolds and the results are presented in Figures 76 and 77, respectively. The pressure drop in manifolds varies from 46.7 kPa (6.78 psi) for a simulated full-scale inlet condition to 27.1 kPa (3.93 psi) for a simulated full scale exit condition. However, the pressure drop in the inner chamber is the only contributor to non-uniformity of flow through the panel, and is less than 10% of the total pressure drop in the manifold. Based on the above computed pressure drops, flow through the test panel has been computed to be within  $\pm 5\%$  of the nominal, as shown in Table 10. Analyses indicate a  $\pm 5\%$  deviation in coolant flow through the panel results in less than a  $\pm 2.8K$  ( $\pm 5^{\circ}F$ ) change in panel temperatures.

Location	Pressure Drop		APS Mass	
	(kPa)	(psi)	(kg/m <sup>2</sup> )	(lbm/ft <sup>2</sup> )
1-2, Entrance to Manifold	7.30	1.06	0.0175	0.0036
2-3, Outer Manifold Chamber	3.65	0.53	0.0087	0.0018
3-4, 180 <sup>0</sup> Turn	23.58	3.42	0.0565	0.0116
4-5, Inner Manifold Chamber	3.51	0.51	0.0084	0.0017
6 , Entrance to Coolant Tube	8.69	1.26	0.0208	0.0043
Total	46.73	6.78	0.1120	0.0230

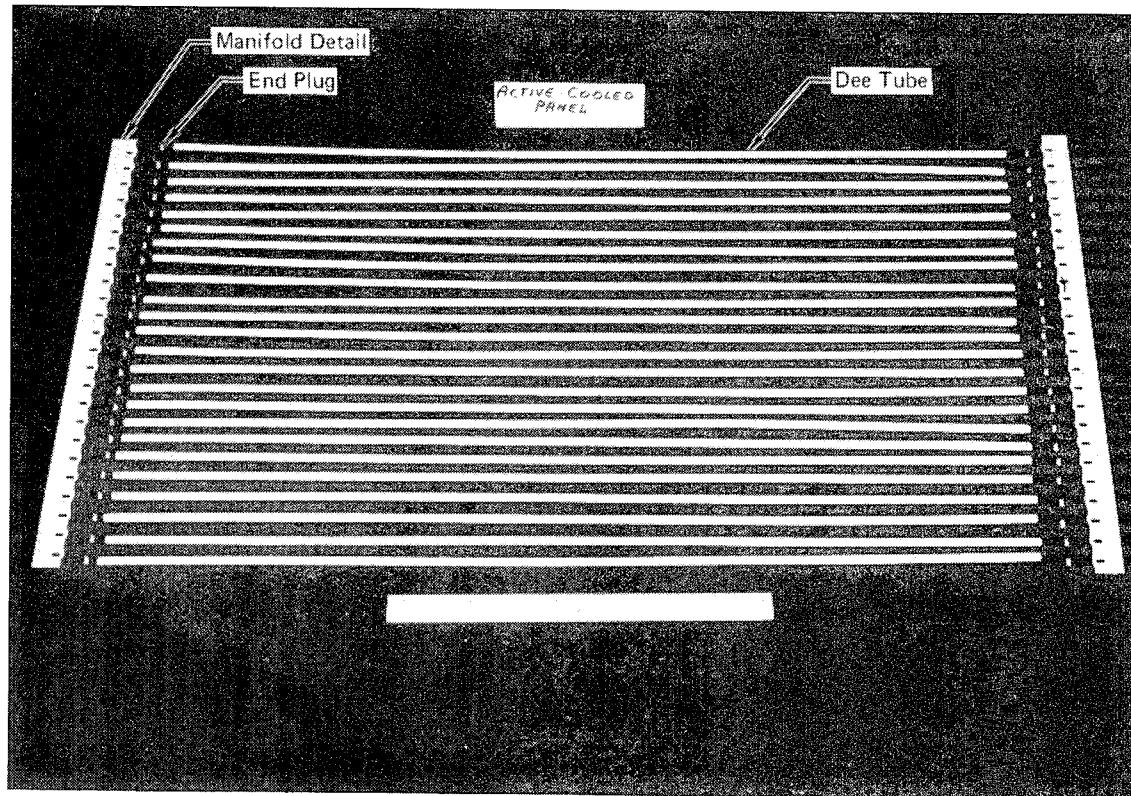
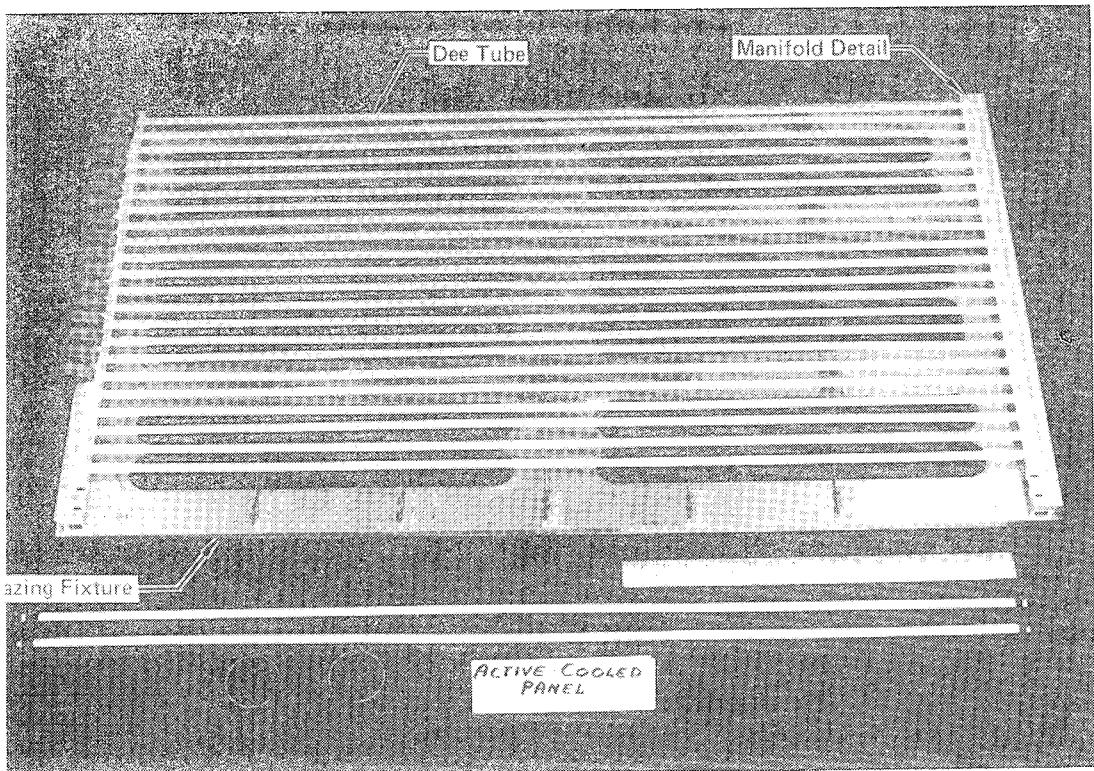
FIGURE 78  
DEE TUBES, END PLUGS, AND MANIFOLD DETAIL

Figures 78 through 83 show the subassemblies in various stages of fabrication. The Dee tubes, the Dee tube end plugs, and the manifold details are shown in Figure 78. These components comprise the manifold/Dee tube subassembly. This subassembly was brazed in one operation.

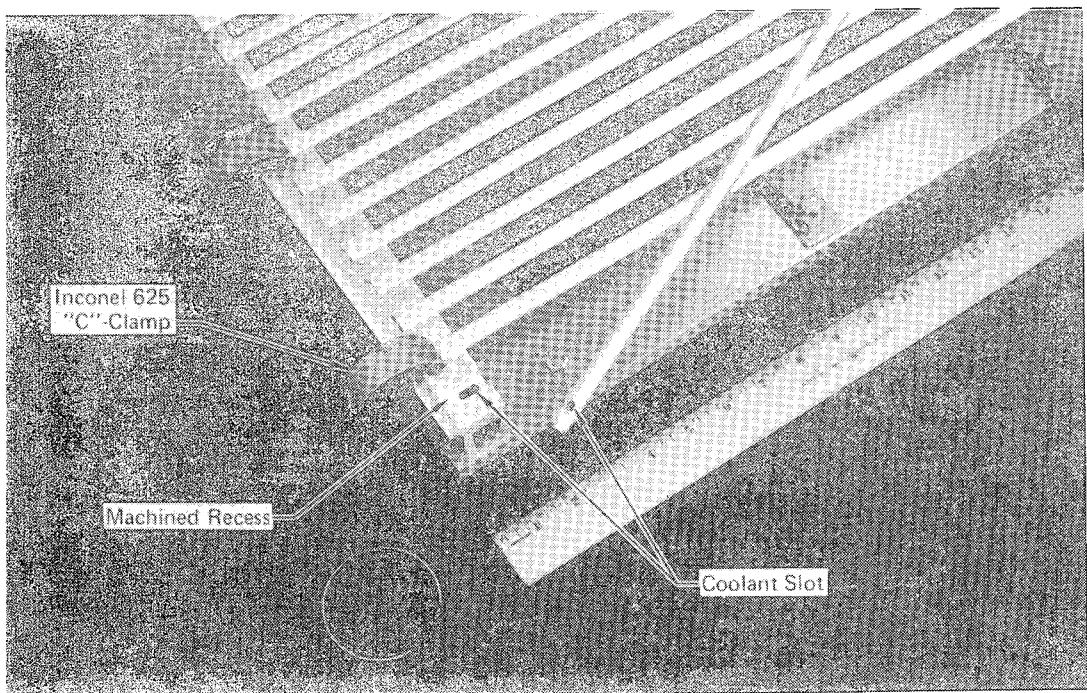
**FIGURE 79**  
**TUBES/MANIFOLD DETAIL/BRAZING TOOL AND CLAMPS**

Figure 79 shows the Dee tubes in position in the machined manifold detail and a close-up of the corner area, showing the recess and the slot machined into the manifold detail and the corresponding slot in the Dee tube. Inconel 625 "C"-clamps were used to maintain pressure between the manifold and the Dee tubes during brazing. The brazing fixture shown in Figure 79 was subsequently discarded when it was found that differential expansion between the Dee tubes and the brazing fixture created gaps between the ends of the tubes and the manifold detail. The final brazing operation used a 1.7 cm (0.50 in.) thick aluminum plate located directly under each manifold to permit the Inconel "C"-clamp to clamp more directly. Figure 80 shows the salt bath brazing operation. Figure 81 shows the completed (brazed tubes and welded manifolds) tube/manifold assembly.

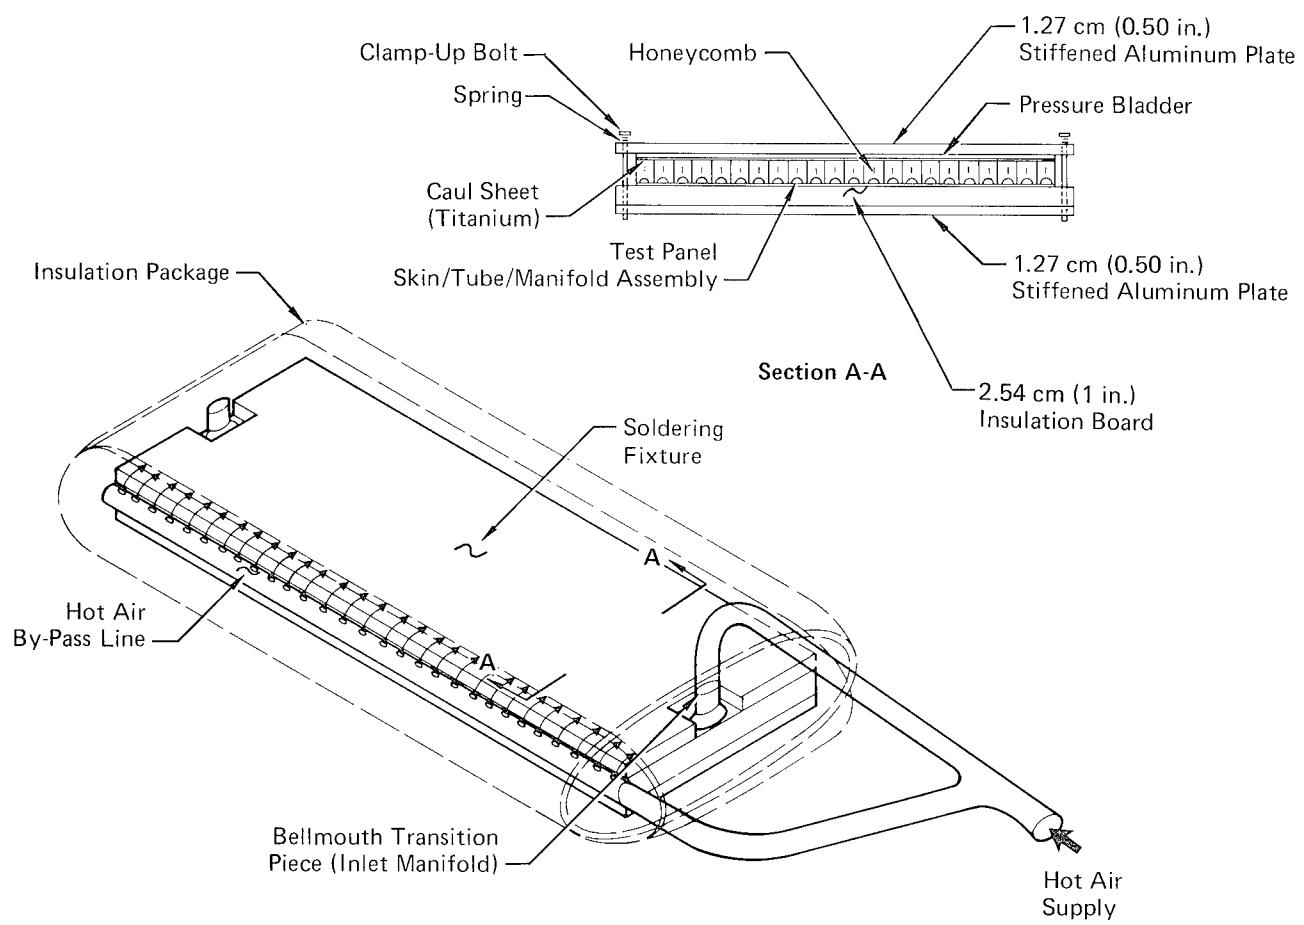
**FIGURE 84**  
**SETUP FOR MAINTAINING CORRECT SOLDERING**  
**TEMPERATURE PROFILE**

During soldering, the panel assembly was sandwiched between two 1.72 cm (0.50 in.) thick stiffened aluminum plates, as illustrated in Figure 84. These thick aluminum plates were required to react the 24.1 kPa (3.5 psi) bladder pressure used to hold the Dee tubes in contact with the outer skin. A hard insulation board was provided to thermally isolate the panel from the lower pressure plate. The honeycomb core and bladder similarly restricted heat transfer between the panel and upper pressure plate. The panel assembly was heated by blowing hot air through the tube/manifold assembly, and around the soldering fixture as shown in Figure 84. Thermocouples, located on the panel, were monitored and the air temperature, pressure, and flow rate was varied in order to achieve the required soldering thermal cycle. This cycle involved increasing the panel temperature from 450K ( $350^{\circ}\text{F}$ ) to 505K ( $450^{\circ}\text{F}$ ) in five minutes, holding at 505K ( $450^{\circ}\text{F}$ ) for two minutes, and then cooling to 460 ( $370^{\circ}\text{F}$ ) in less than five minutes (reference Appendix C). Examination of the panel after soldering revealed some areas were not soldered, some areas had many voids, soldered joints had very low strength, and that extensive intergranular cracking occurred in the coolant tubes.

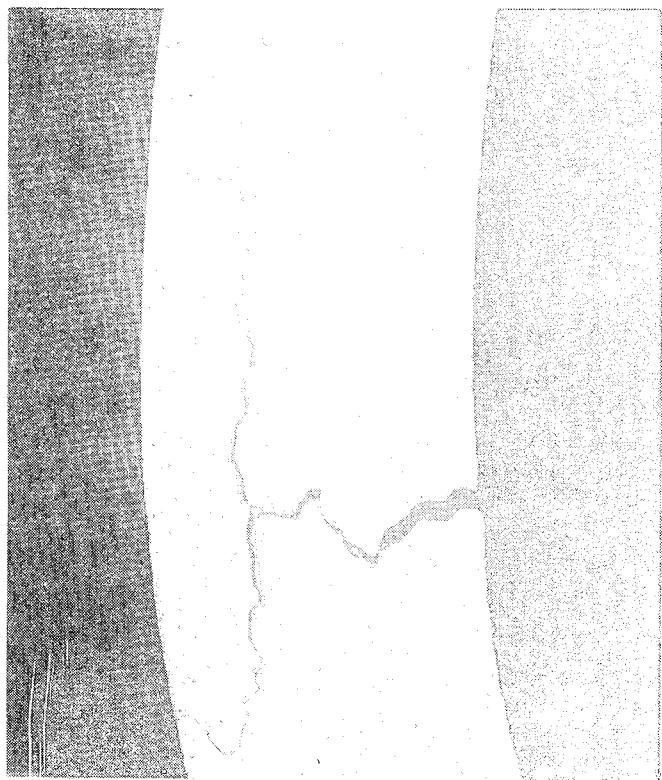
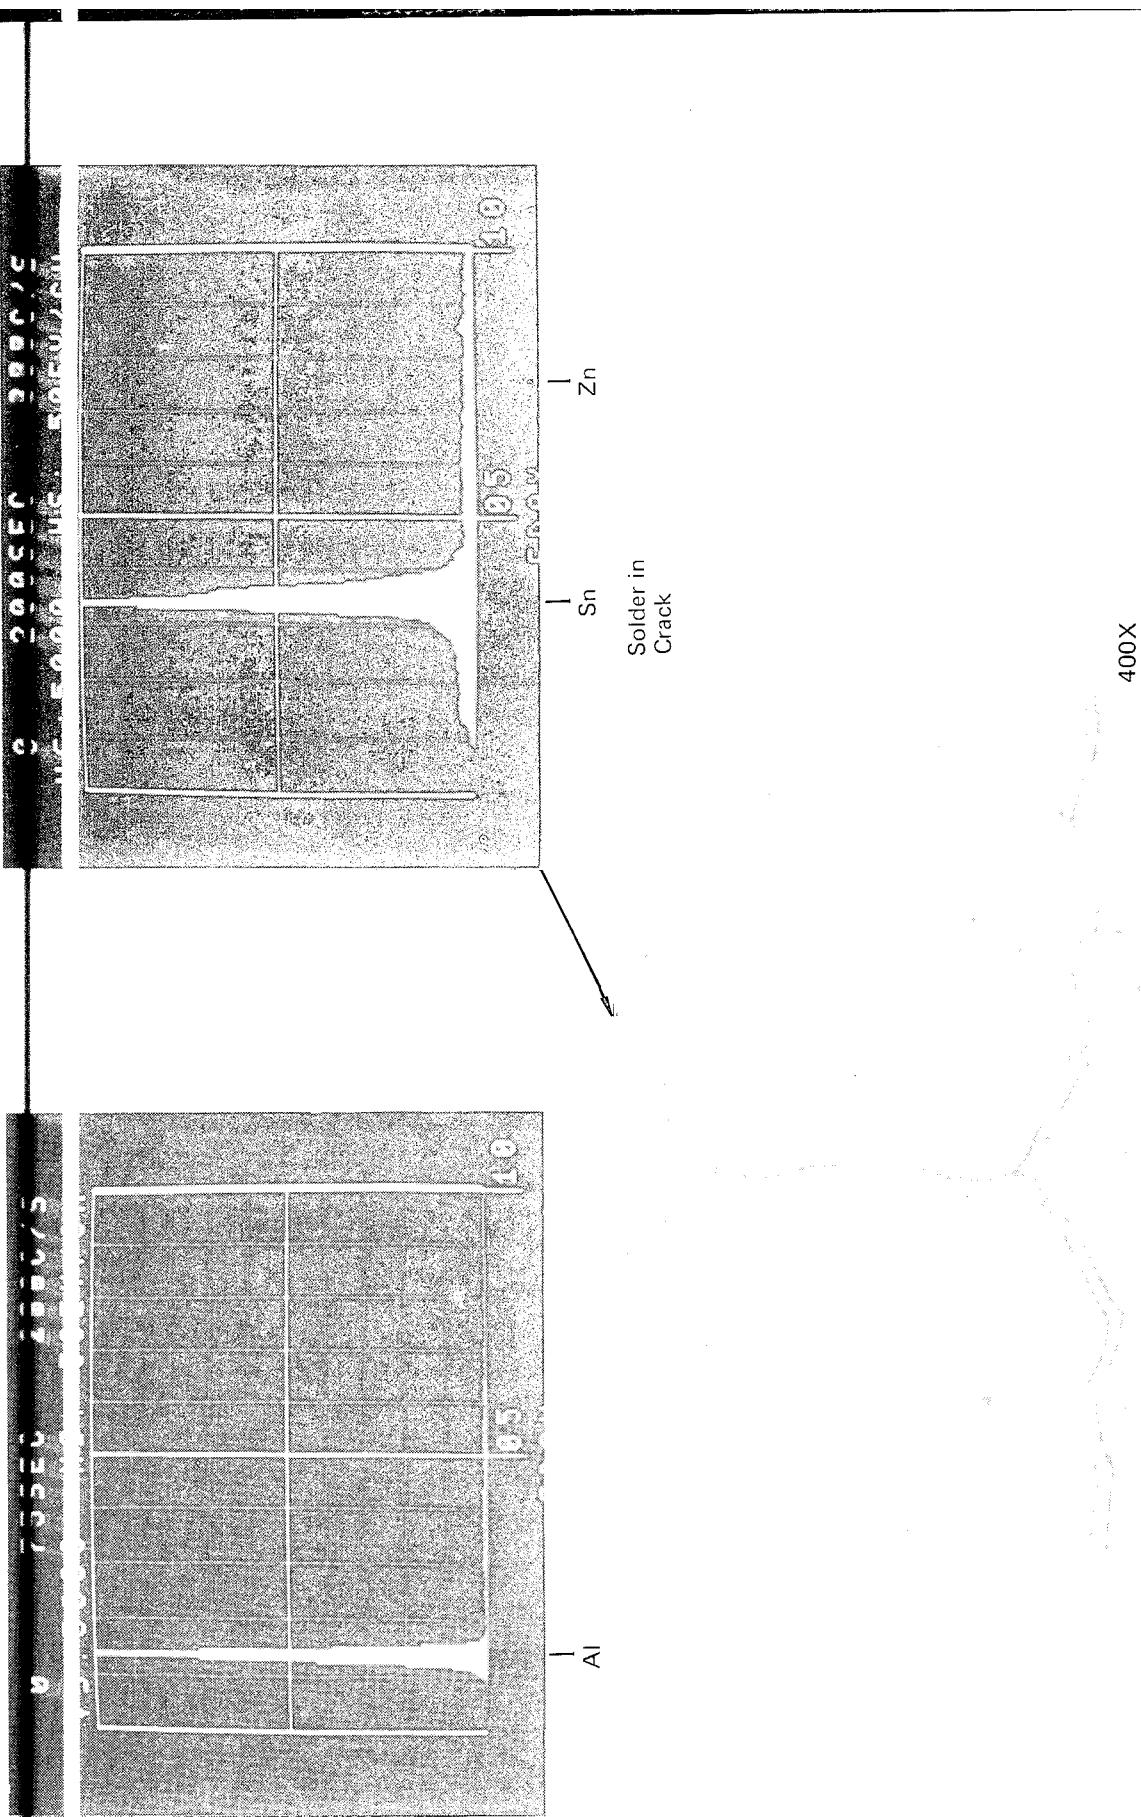
Etched - 50X

Unetched - 50X

FIGURE 87  
MICROSTRUCTURE OF CRACKS IN 6061-T6 TUBE

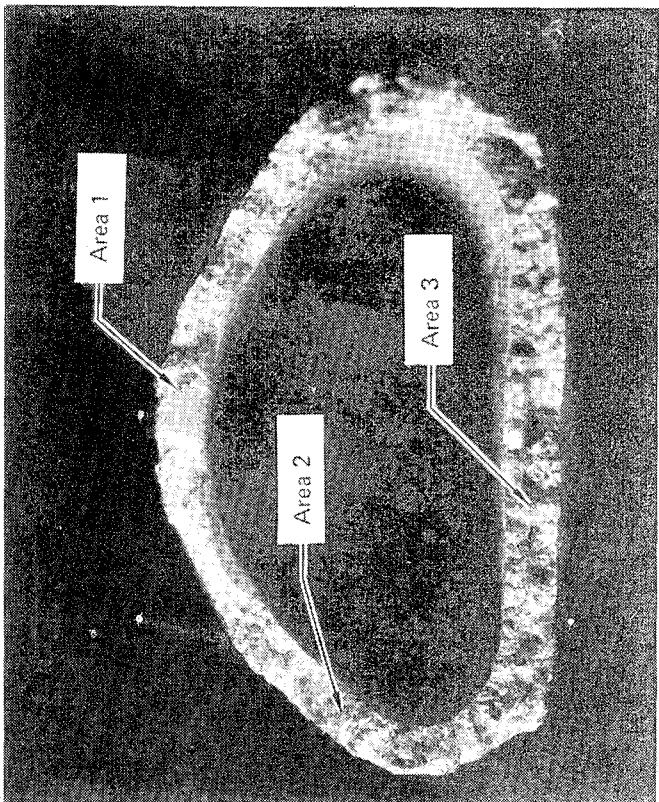
Solder Covered Surface (SEM)

- Area 3 -

Cross Section - Ruptured Tube

Note:  
Areas 2 and 3 cracked in processing.  
Area 1 mechanically fractured for examination.

FIGURE 88  
SOLDER MIGRATED INTO CRACK IN TUBE DURING SOLDERING OPERATION

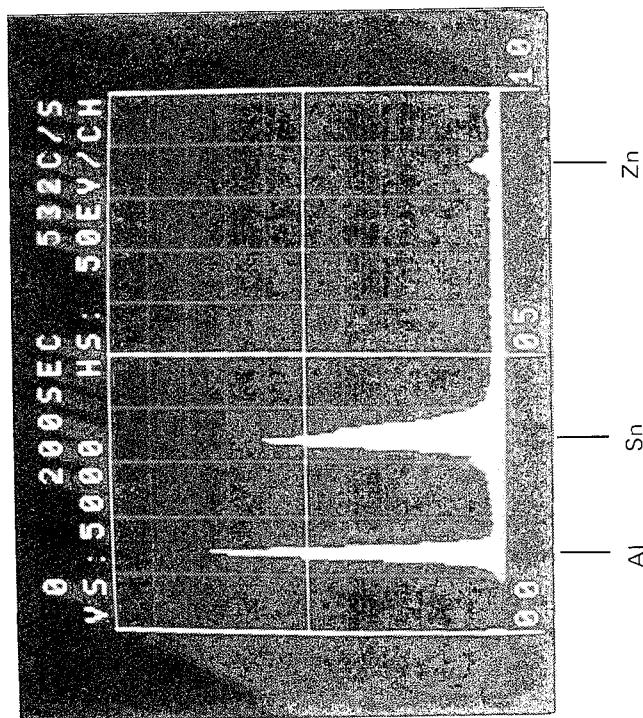
Fracture - Solder Contamination  
Area 2 - SEM-100X

FIGURE 89  
EDAX INDICATES SOLDER MIGRATED INTO CRACK IN TUBE DURING  
SOLDERING OPERATION

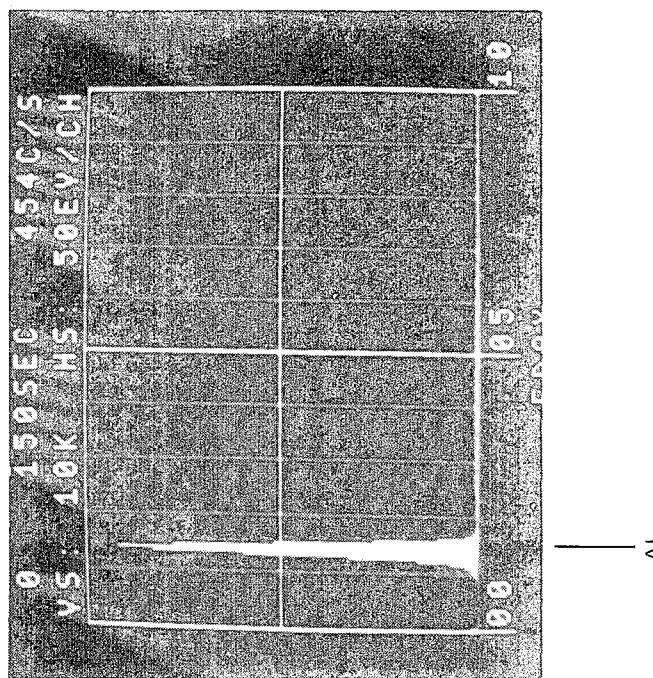
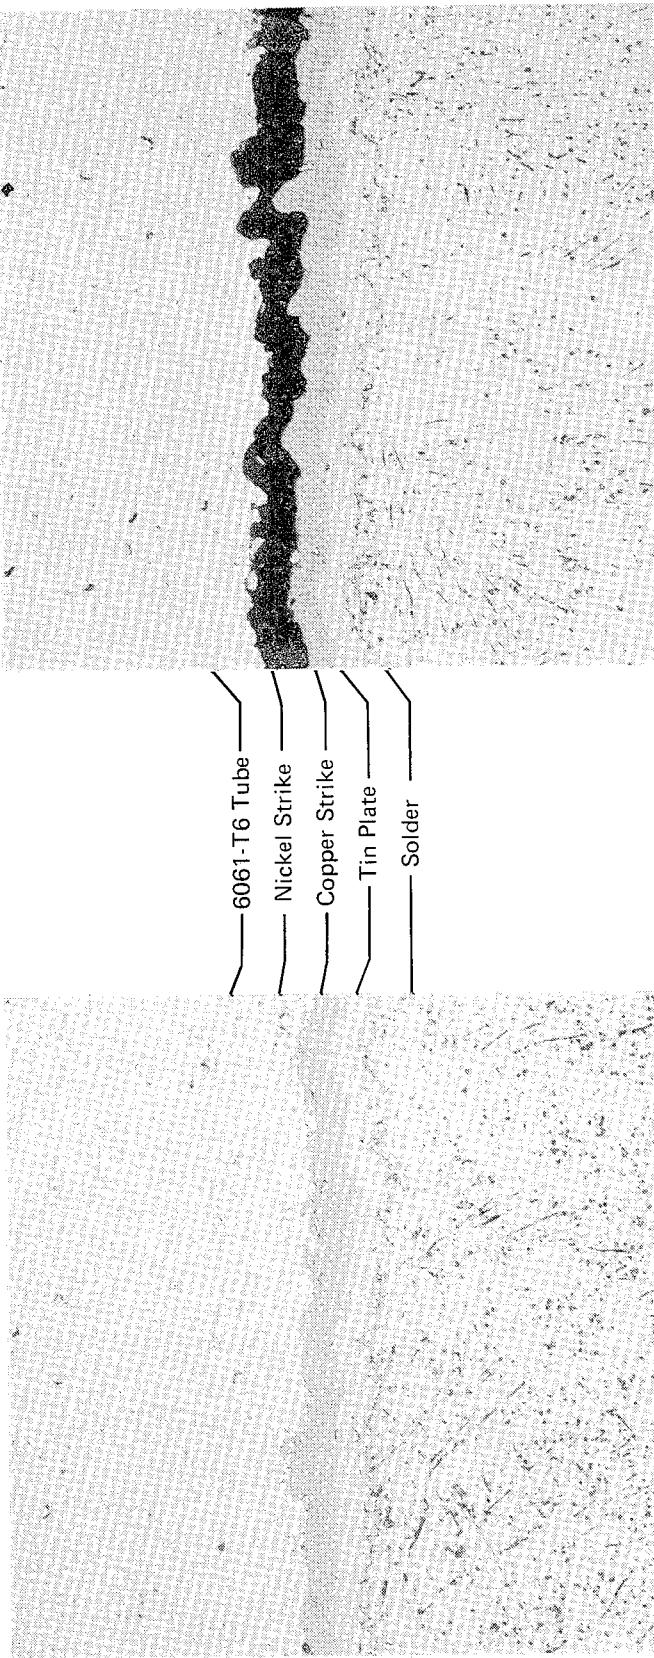
Fracture - No Solder  
Area 1 - SEM-100X

FIGURE 90  
EDAX INDICATES NO SOLDER ON MECHANICALLY  
FRACTURED AREA OF TUBE

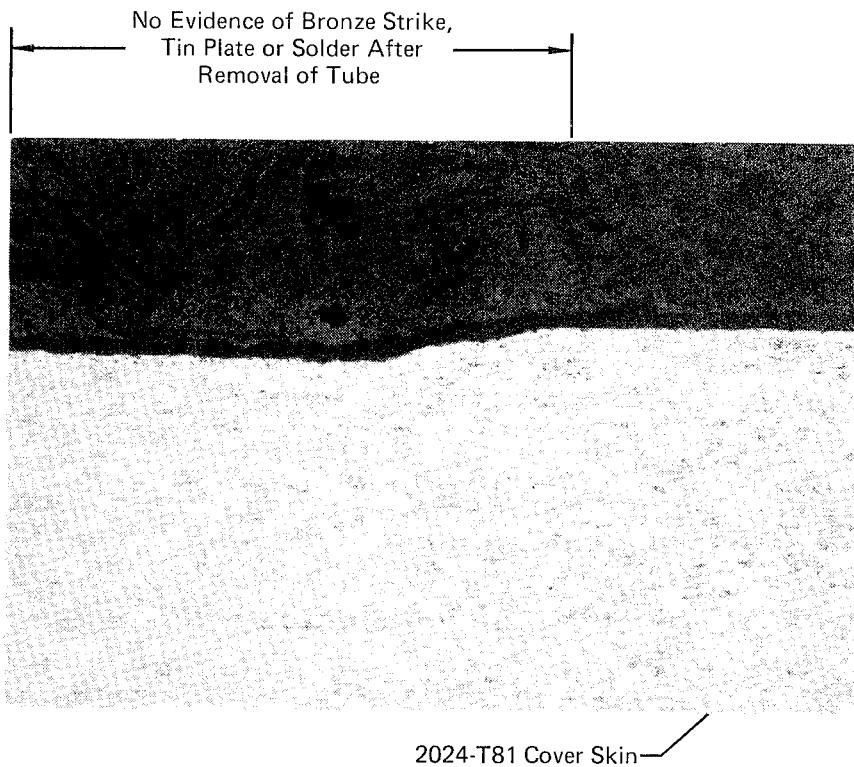
A photomicrograph of a cross section in the tube/manifold area is shown in Figure 91. This figure compares a "sound" soldered joint to an unsoldered joint. This was typical of several areas where poor solder wetting was identified. Note the separation of the copper strike at the tube boundary. Figure 92 shows a photomicrograph of the 2024-T81 skin in an area where voids existed. In this area there was no evidence of the bronze strike, tin plate or solder, which indicated complete erosion due to the solder penetrating the plating on the 2024-T81.

**FIGURE 92**  
**INDICATION OF EROSION APPARENTLY DUE TO SOLDER PENETRATING**  
**PLATING ON 2024-T81**
